Order number: PV776-TSP144851

General

SRS Airbag, Safety Belts and Bunk Restraints

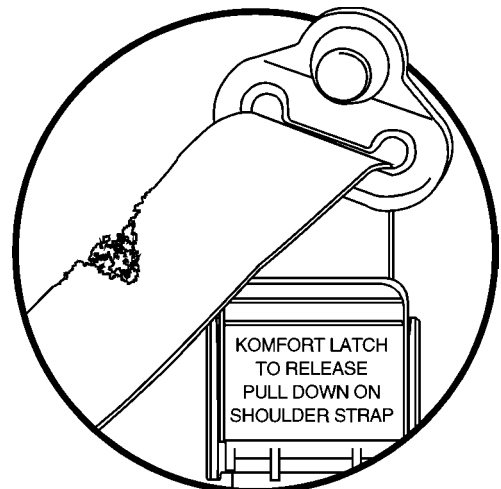
W8001405

The D-loop web guide is an area where almost constant movement of the safety belt webbing occurs because of the relative movement between the seat and the cab. Because of this constant movement this is an area where wear will often occur. The webbing must be closely examined to determine if there are any cuts, frays or extreme wear in the webbing. Cuts, frays or excessive wear indicate the need for replacement of the safety belt system.
